Manhole Inspection Summary

Manhole # S53C__032MH

Insp Date: **6/13/08 12:43 PM**

Location Address: **3108 e baltimore st**

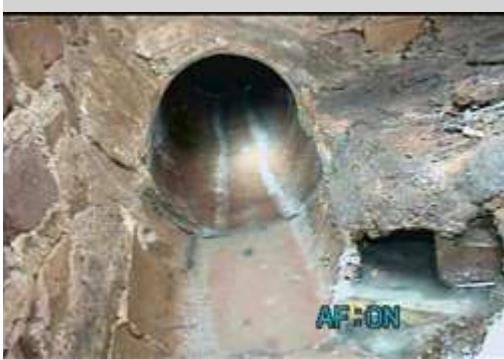
Defect 1

Condition: ☐ Sound ☐ Cracked ☐ Root Intrusion ☒ **Deteriorated** ☐ Leaks ☐ Debris

Bench deteriorated

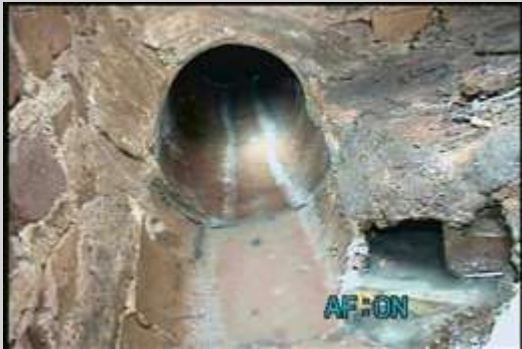
12 O'Clock Outflow

8 in. Circular Gravity Sewer
Pipe Out @ 12 O'Clock

Pipe Material: **Clay** ☐ Pipe Lined

Invert Depth: **5.47** (ft.) Flow Characteristics: **Slow**

Deposits: ☒ None ☐ Mud ☐ Sludge ☐ Debris ☐ Grease

Infiltration: **None** Pipe Seal Cond: **Unknown**

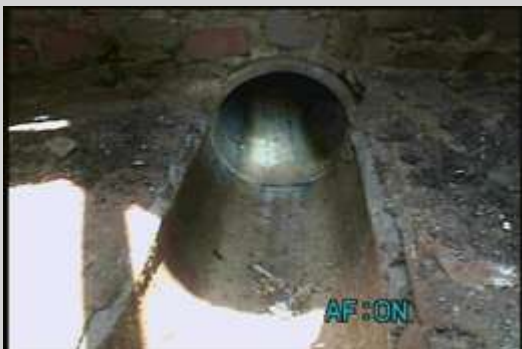
3 O'Clock Inflow

8 in. Circular Gravity Sewer
Pipe In @ 3 O'Clock

Pipe Material: **Clay** ☐ Pipe Lined

Invert Depth: **5.43** (ft.) Flow Characteristics: **Slow**

Deposits: ☒ None ☐ Mud ☐ Sludge ☐ Debris ☐ Grease

Infiltration: **None** Pipe Seal Cond: **Unknown**

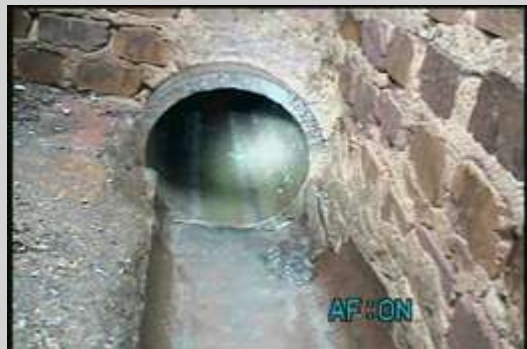
6 O'Clock Inflow

8 in. Circular Gravity Sewer
Pipe In @ 6 OClock

Pipe Material: **Clay** ☐ Pipe Lined

Invert Depth: **5.40** (ft.) Flow Characteristics: **Slow**

Deposits: ☒ None ☐ Mud ☐ Sludge ☐ Debris ☐ Grease

Infiltration: **None** Pipe Seal Cond: **Unknown**
